1768 CompactLogix Controllers, Revision 20

CompactLogix Catalog Numbers 1768-L43, 1768-L45

Compact GuardLogix Catalog Numbers 1768-L43S, 1768-L45S

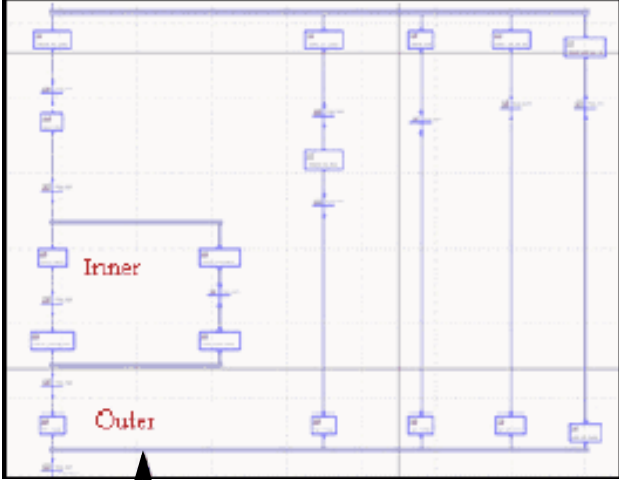
| Cat. No. | Description |
|--|---|
| 1768-L43, 1768-L45, 1768-L43S, 1768-L45S | <p>CORRECTED: An anomaly can occur when you nest simultaneous branches in a Sequential Function Chart (SFC) routine as shown below.</p> <p style="text-align: center;">Bottom-most Steps</p> <p>During normal operations, the logic does not step out of a simultaneous branch until all of the incoming legs have reached their bottom-most step. In the example shown, the logic does not step out of the Outer simultaneous branch until the leftmost leg has stepped out of the Inner simultaneous branch. The first time through the SFC routine, the application works as expected. On subsequent scans, however, the chart steps out of the Outer simultaneous branch even though the left leg has not reached the Inner simultaneous branch yet.</p> <p>This behavior occurs because the information in the bottom step, that is, the step next to the word Outer, remains from the previous scan. This stale information incorrectly causes the transition to move on as if the left leg is at the bottom step when it actually is not.</p> <p>To work around this anomaly, confirm all of the incoming legs have reached their bottom steps in the transition. You can check the .x bits to make sure the bottom-most step of each converging leg is active before allowing the chart to advance. This check can be added to the transition logic already present.</p> <p>For example, the steps in the following expression are the bottom steps (see graphic above) of the incoming legs. Each step has a timer. The transition does not move on until all of the step timers have reached their preset value.</p> <p>The expression can be modified to be sure those steps are truly active. This is the original expression:</p> <pre>// Unit is ready to Transition Step1_ready.dn and Step2_ready.dn and Step3_ready.dn and Step4_ready.dn and Step5_ready.dn</pre> <p>This is the modified expression to work around this anomaly.</p> <pre>// Unit is ready to Transition Step1_ready.x and Step2_ready.x and Step3_ready.x and Step4_ready.x and Step5_ready.x and Step1_ready.dn and Step2_ready.dn and Step3_ready.dn and Step4_ready.dn and Step5_ready.dn</pre> <p>IMPORTANT: The x bit is cleared when the chart transitions out of a step.</p> <p>Adding this check to the condition forces the engine to wait until all of those steps are genuinely active before advancing out of the simultaneous branch.</p> <p style="text-align: right;">Lgx00118188, Lgx00116506</p> <p>CORRECTED: Applications that have a large quantity of HMI tags on scan in the controller can experience a non-recoverable major fault when doing online edits.</p> <p style="text-align: right;">Lgx00118192, Lgx00115817</p> |
